The 50th Anniversary
Fantastic Cases In Cardiovascular Imaging. Case 46

History: Fall from 30 ft

Diagnosis: Traumatic Rupture of the Tricuspid chordae tendinae

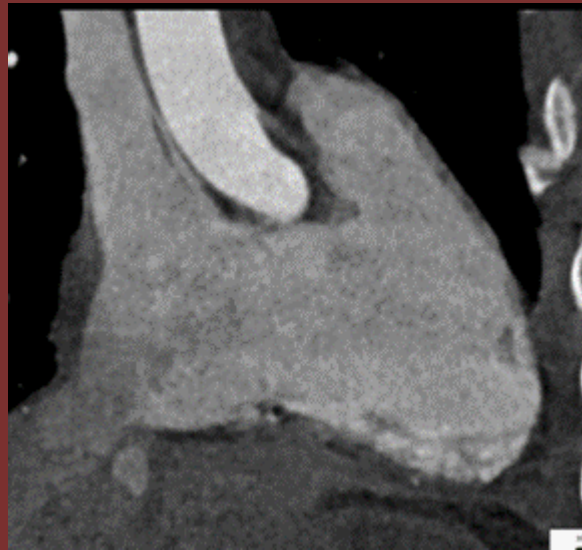
Retrospectively gated cardiac CT shows prolapsing tricuspid valve leaflets. Notice displacement into the right atrium during systole.
